A. INTRODUCTION

The proposed project would involve the installation of a flood protection system generally located within City parkland and streets between Montgomery Street to the south and East 25th Street to the north. The proposed flood protection system would consist of a combination of floodwalls, levees, and/or closure structures that, together with other infrastructure improvements, would improve the resiliency of this area to coastal flooding while simultaneously improving access and community connectivity to the waterfront. The proposed project would require the demolition or disturbance of existing structures, excavation,² and disturbance and removal of some of the existing fill and soil, with the importation of fill material to raise the ground level throughout East River Park. Dewatering of groundwater would also be required. A detailed description of the alternatives analyzed in this chapter is provided in Chapter 2.0, “Project Alternatives.”

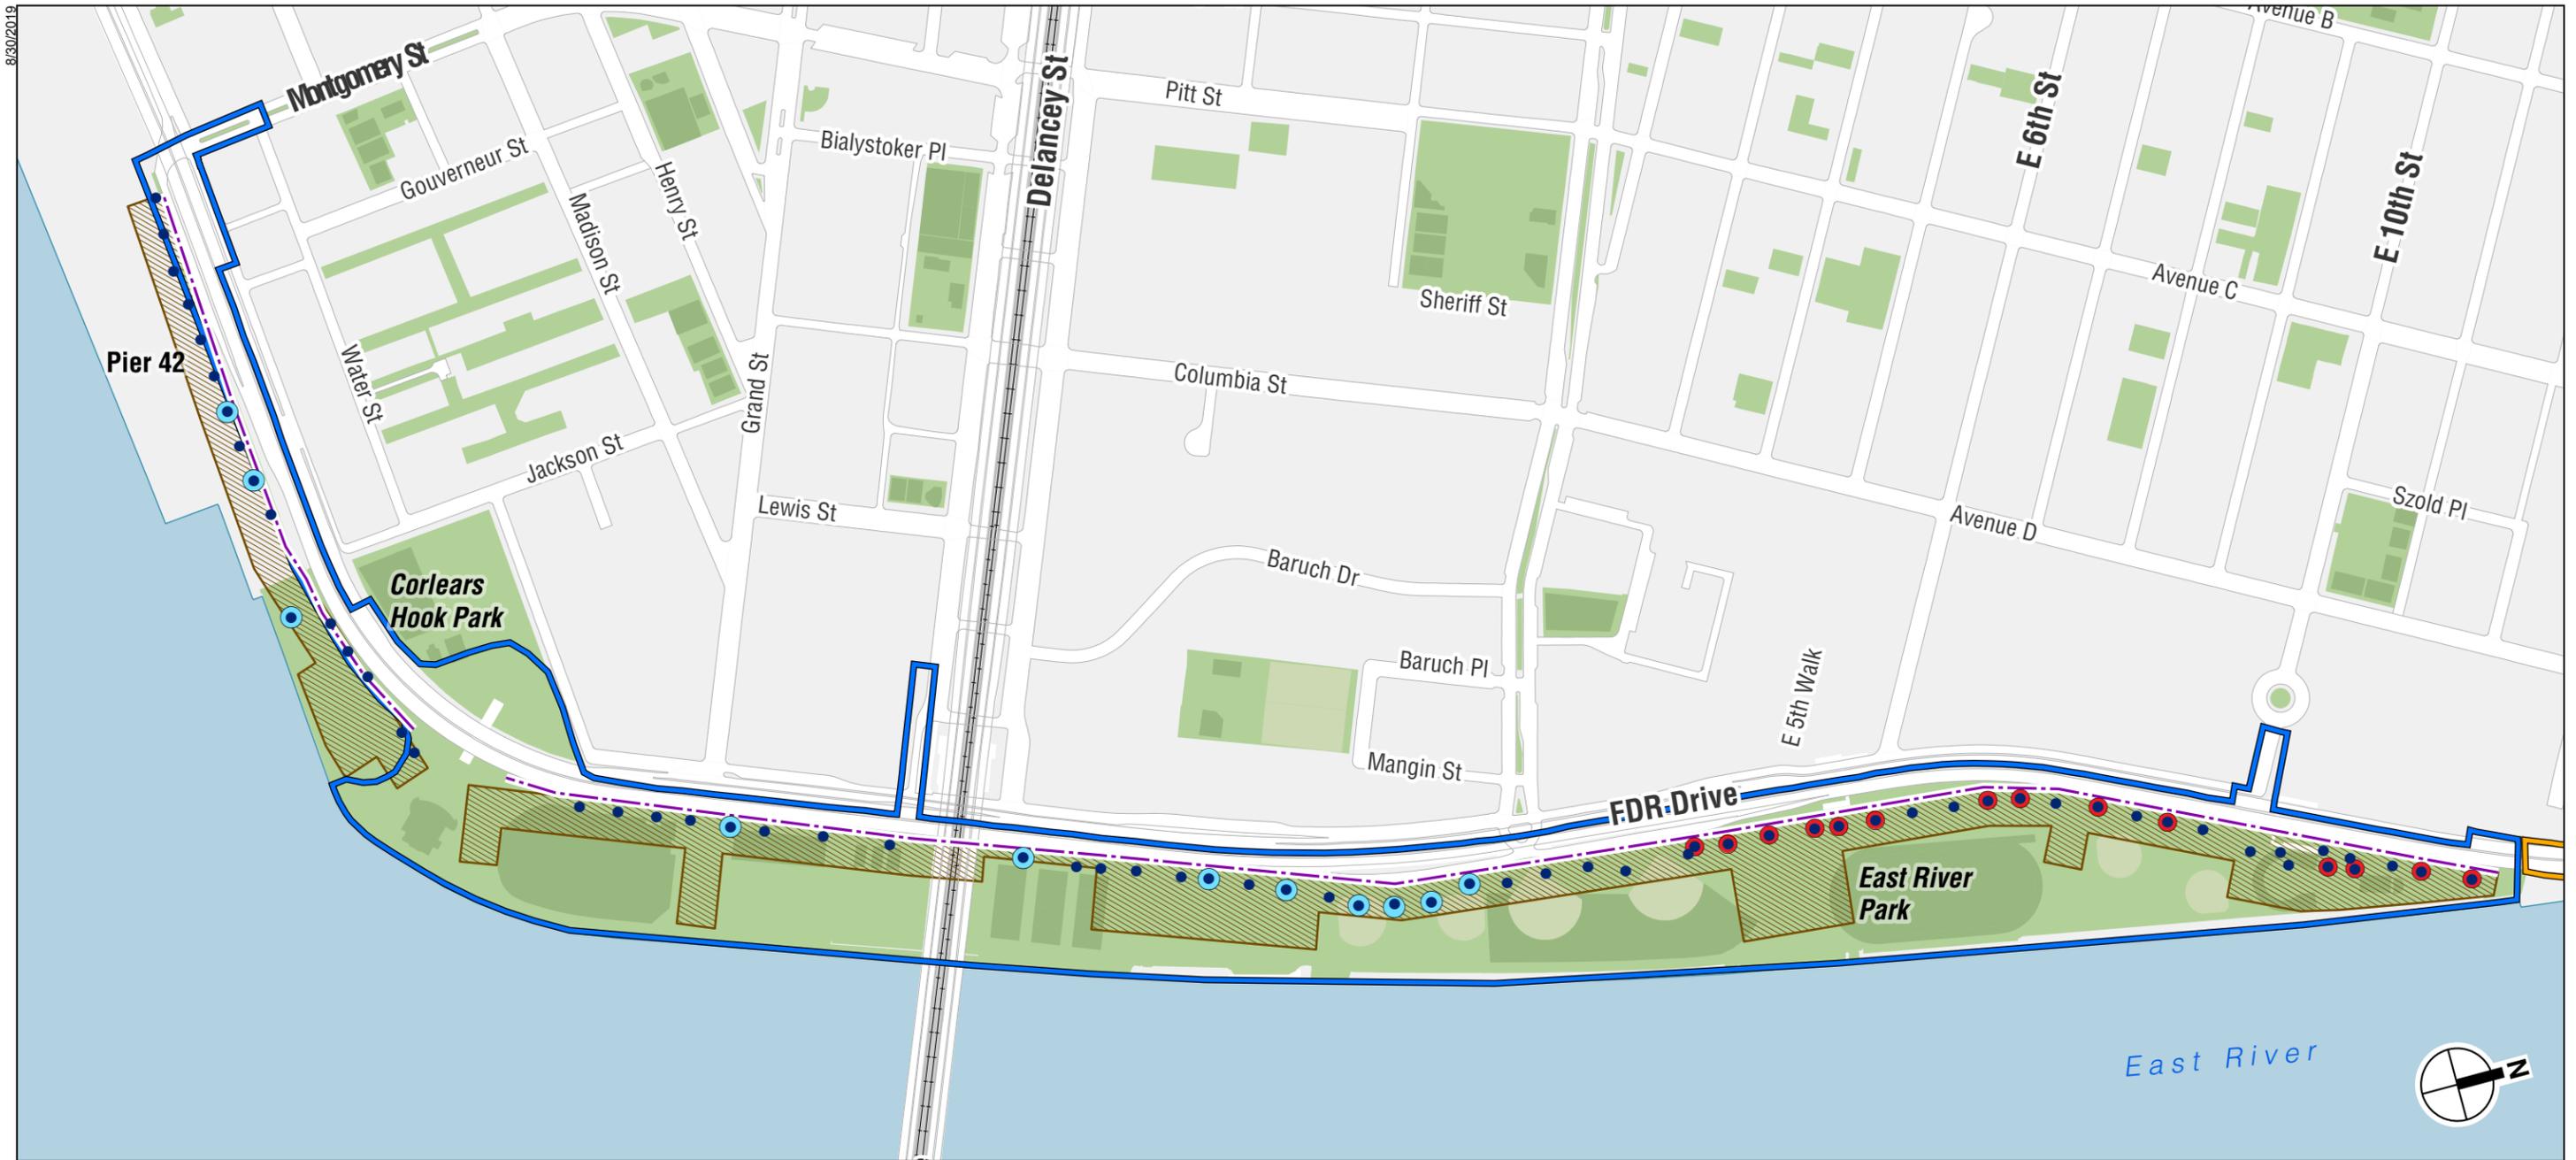
- Project Area One
- Project Area Two
- Deep Boring Alignment
- Shallow Boring Areas
- Deep Soil Boring Location & Designation
- Deep Soil Borings with Petroleum-Like Contamination Encountered at Depths
- Deep Soil Borings with Coal Tar-Like Contamination Encountered at Depths

For this investigation, conducted between April and June 2015, both Project Areas One (south of East 14th Street) and Two (north of East 14th Street) were analyzed and further divided into 100-foot grids for analysis purposes (see **Figures 5.7-1 through 5.7-3**). In each grid, one deep boring (up to 40 feet) was conducted as well as four additional shallow borings. The shallow samples were generally analyzed as composites (i.e., mixture) of shallow soil from the five borings within the grid. For Project Areas One and Two, this resulted in 83 deep samples and 98 shallow samples.

Petroleum-like odors and or low-level photoionization detector (PID) readings, indicating the presence of VOCs, were noted during the field screening of soil from 12 borings as shown on **Figures 5.7-2, 5.7-3, 5.7.5, 5.7.6, 5.7.8, and 5.7.9**. However, laboratory data indicated potential petroleum contamination in only three of these borings—one located slightly south of East Houston Street, one just north of the Williamsburg Bridge, and another near the Solar One site.

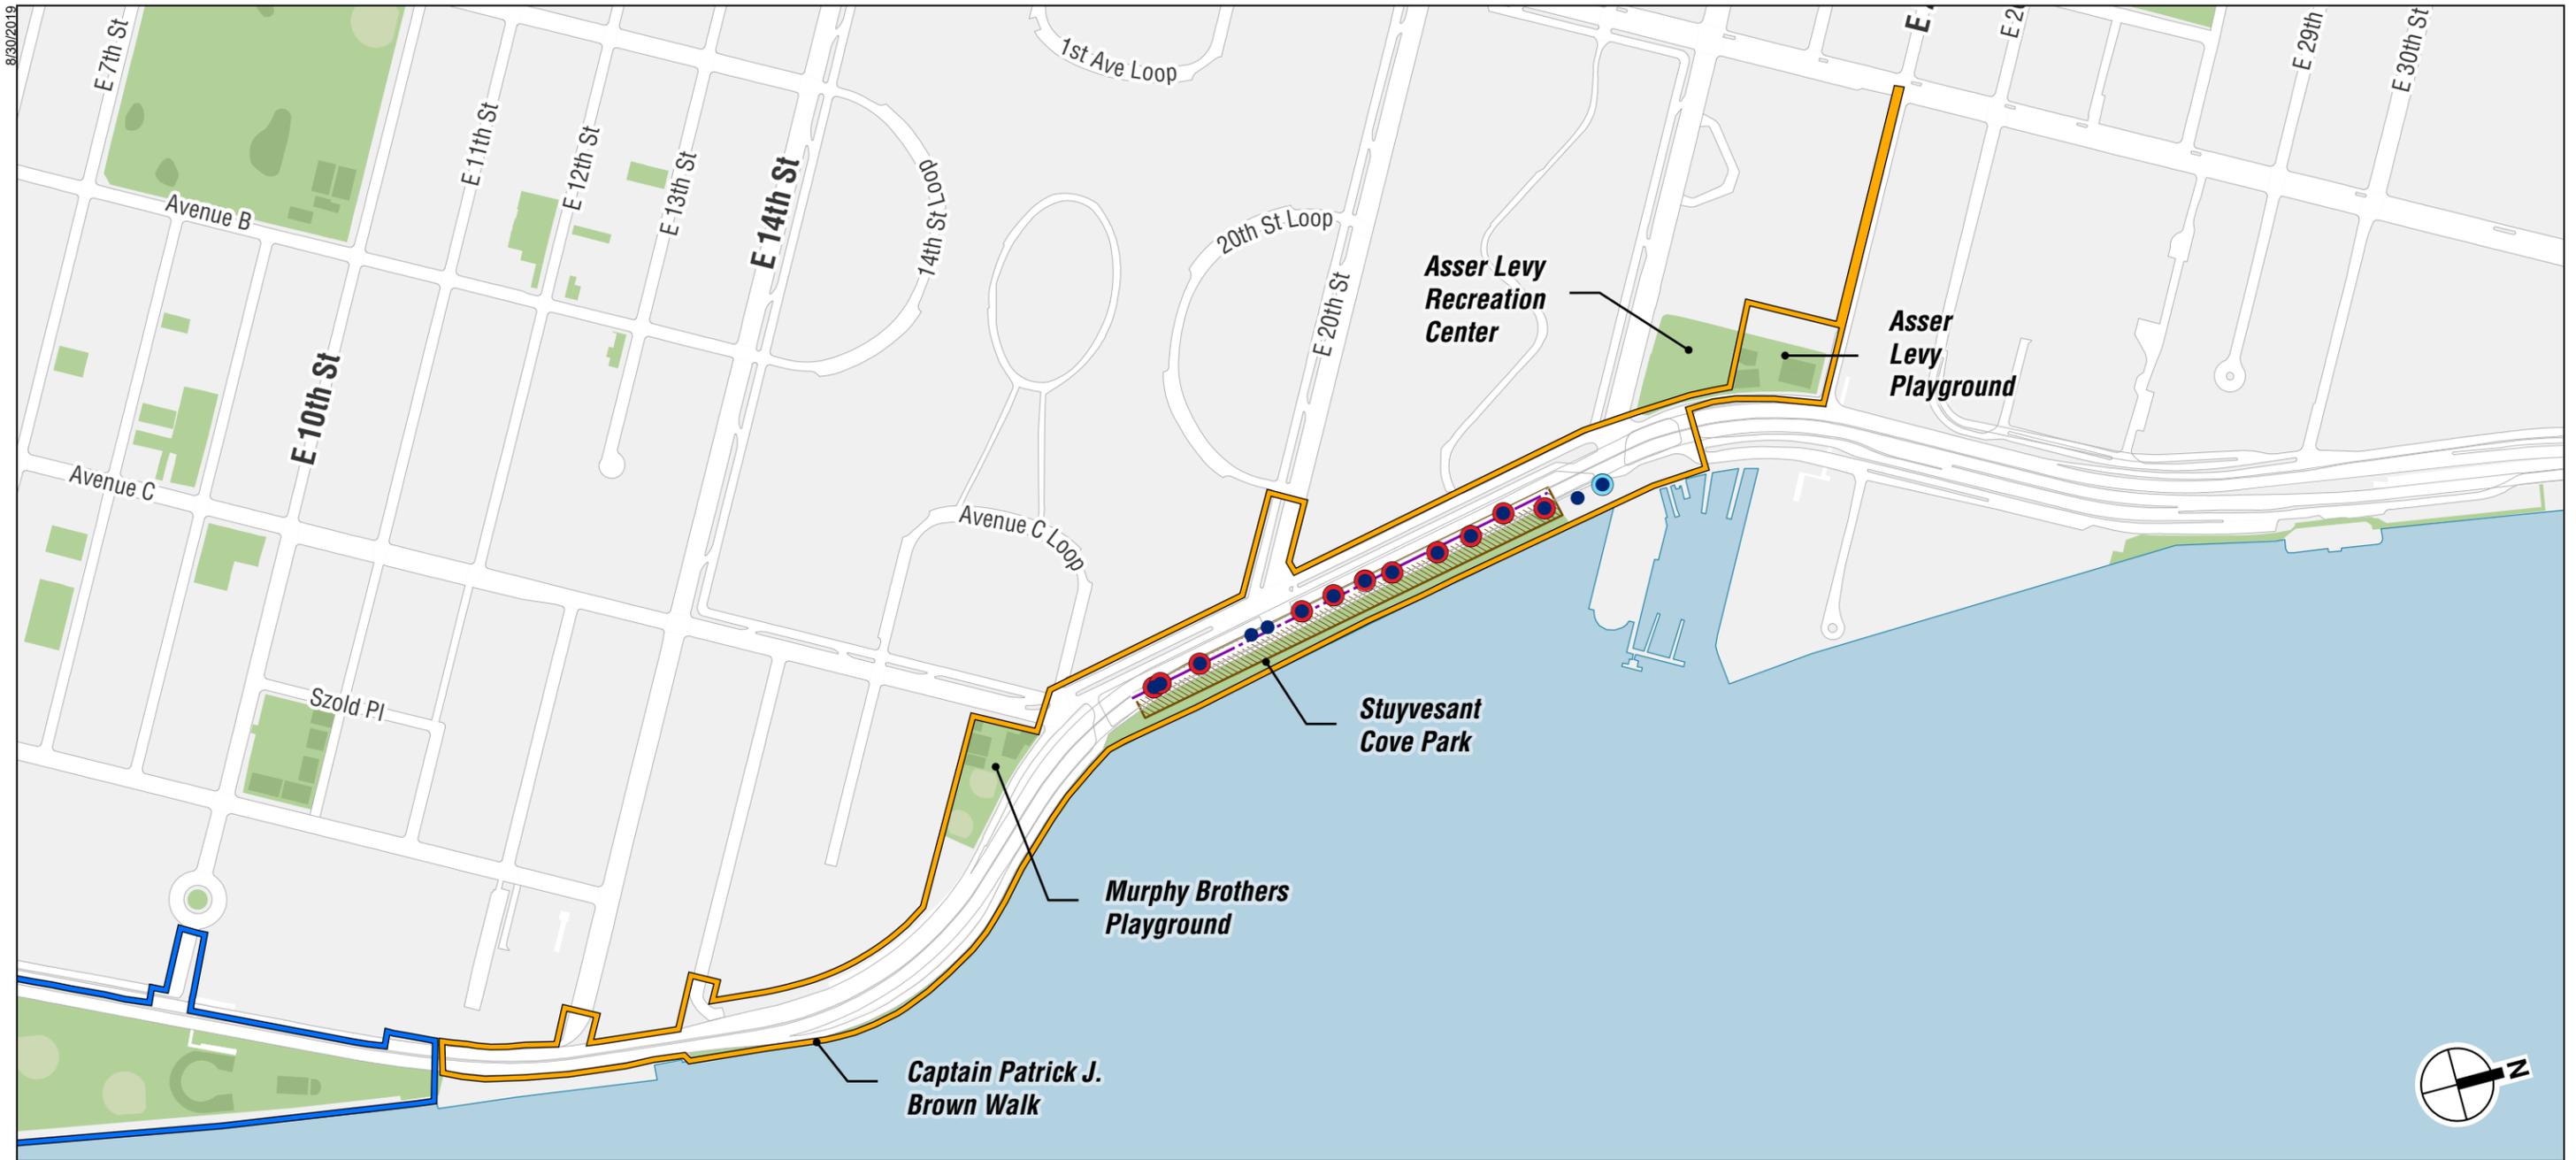
- Project Area One
- Project Area Two
- Shallow Boring Areas
- Deep Soil Boring Location & Designation
- Soil Boring with Coal Tar & Potential Petroleum Impacts
- Soil Borings with Coal Tar-Like Contamination Encountered at Depths

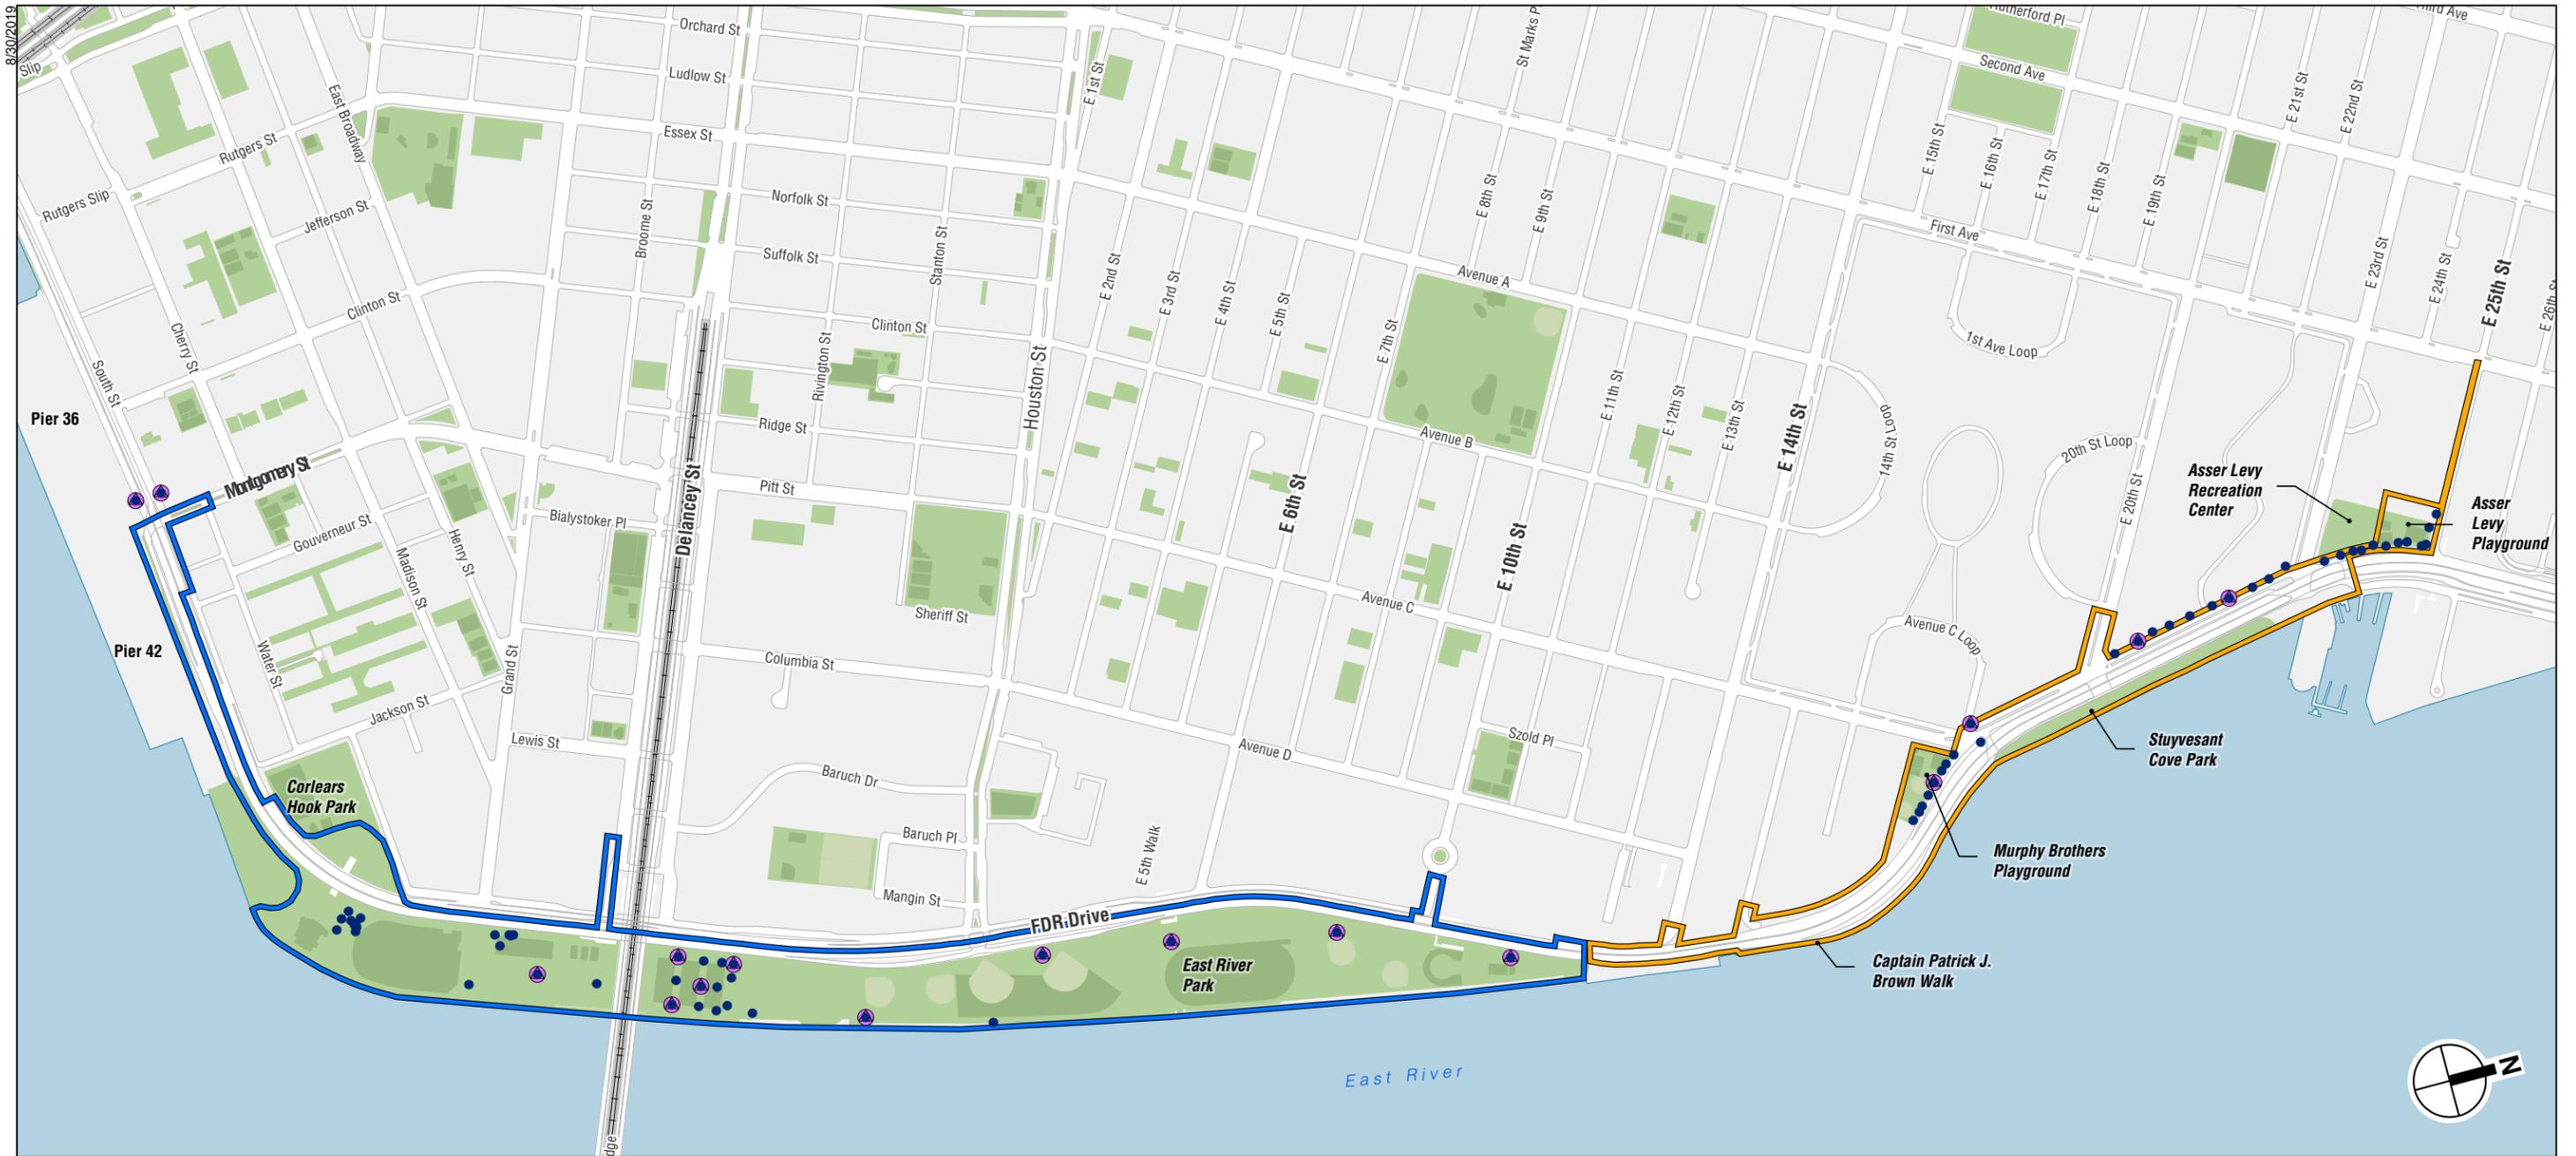
- Project Area One
- Project Area Two
- Soil Boring Location & Designation
- ▲ Groundwater Sample Locations

Supplemental soil and groundwater investigations were conducted in July 2016 (see **Figures 5.7-4 through 5.7-6**), as follows: (1) in areas where the potential for subsurface soil disturbance was better defined based on the project design; (2) in two shallow soil locations where the Spring 2015 investigation identified elevated levels of lead and/or chromium in composite samples; and (3) to obtain additional groundwater quality data in the northern end of East River Park at depths where contamination from former MGPs was identified during the Spring 2015 investigation.

Groundwater during the soil and groundwater investigations was first encountered at approximately 5 to 13 feet below grade; however, more precise groundwater measurements obtained from temporary wells identified the water table at between 5 and 16 feet below grade. While groundwater throughout the project area would be expected to flow toward the East River, local variations are possible due to intervening subsurface structures (such as former or current bulkheads), tidal fluctuation, and past filling. Groundwater in Manhattan is not used as a source of drinking water (see **Figures 5.7-1, 5.7-4, and 5.7-7**).

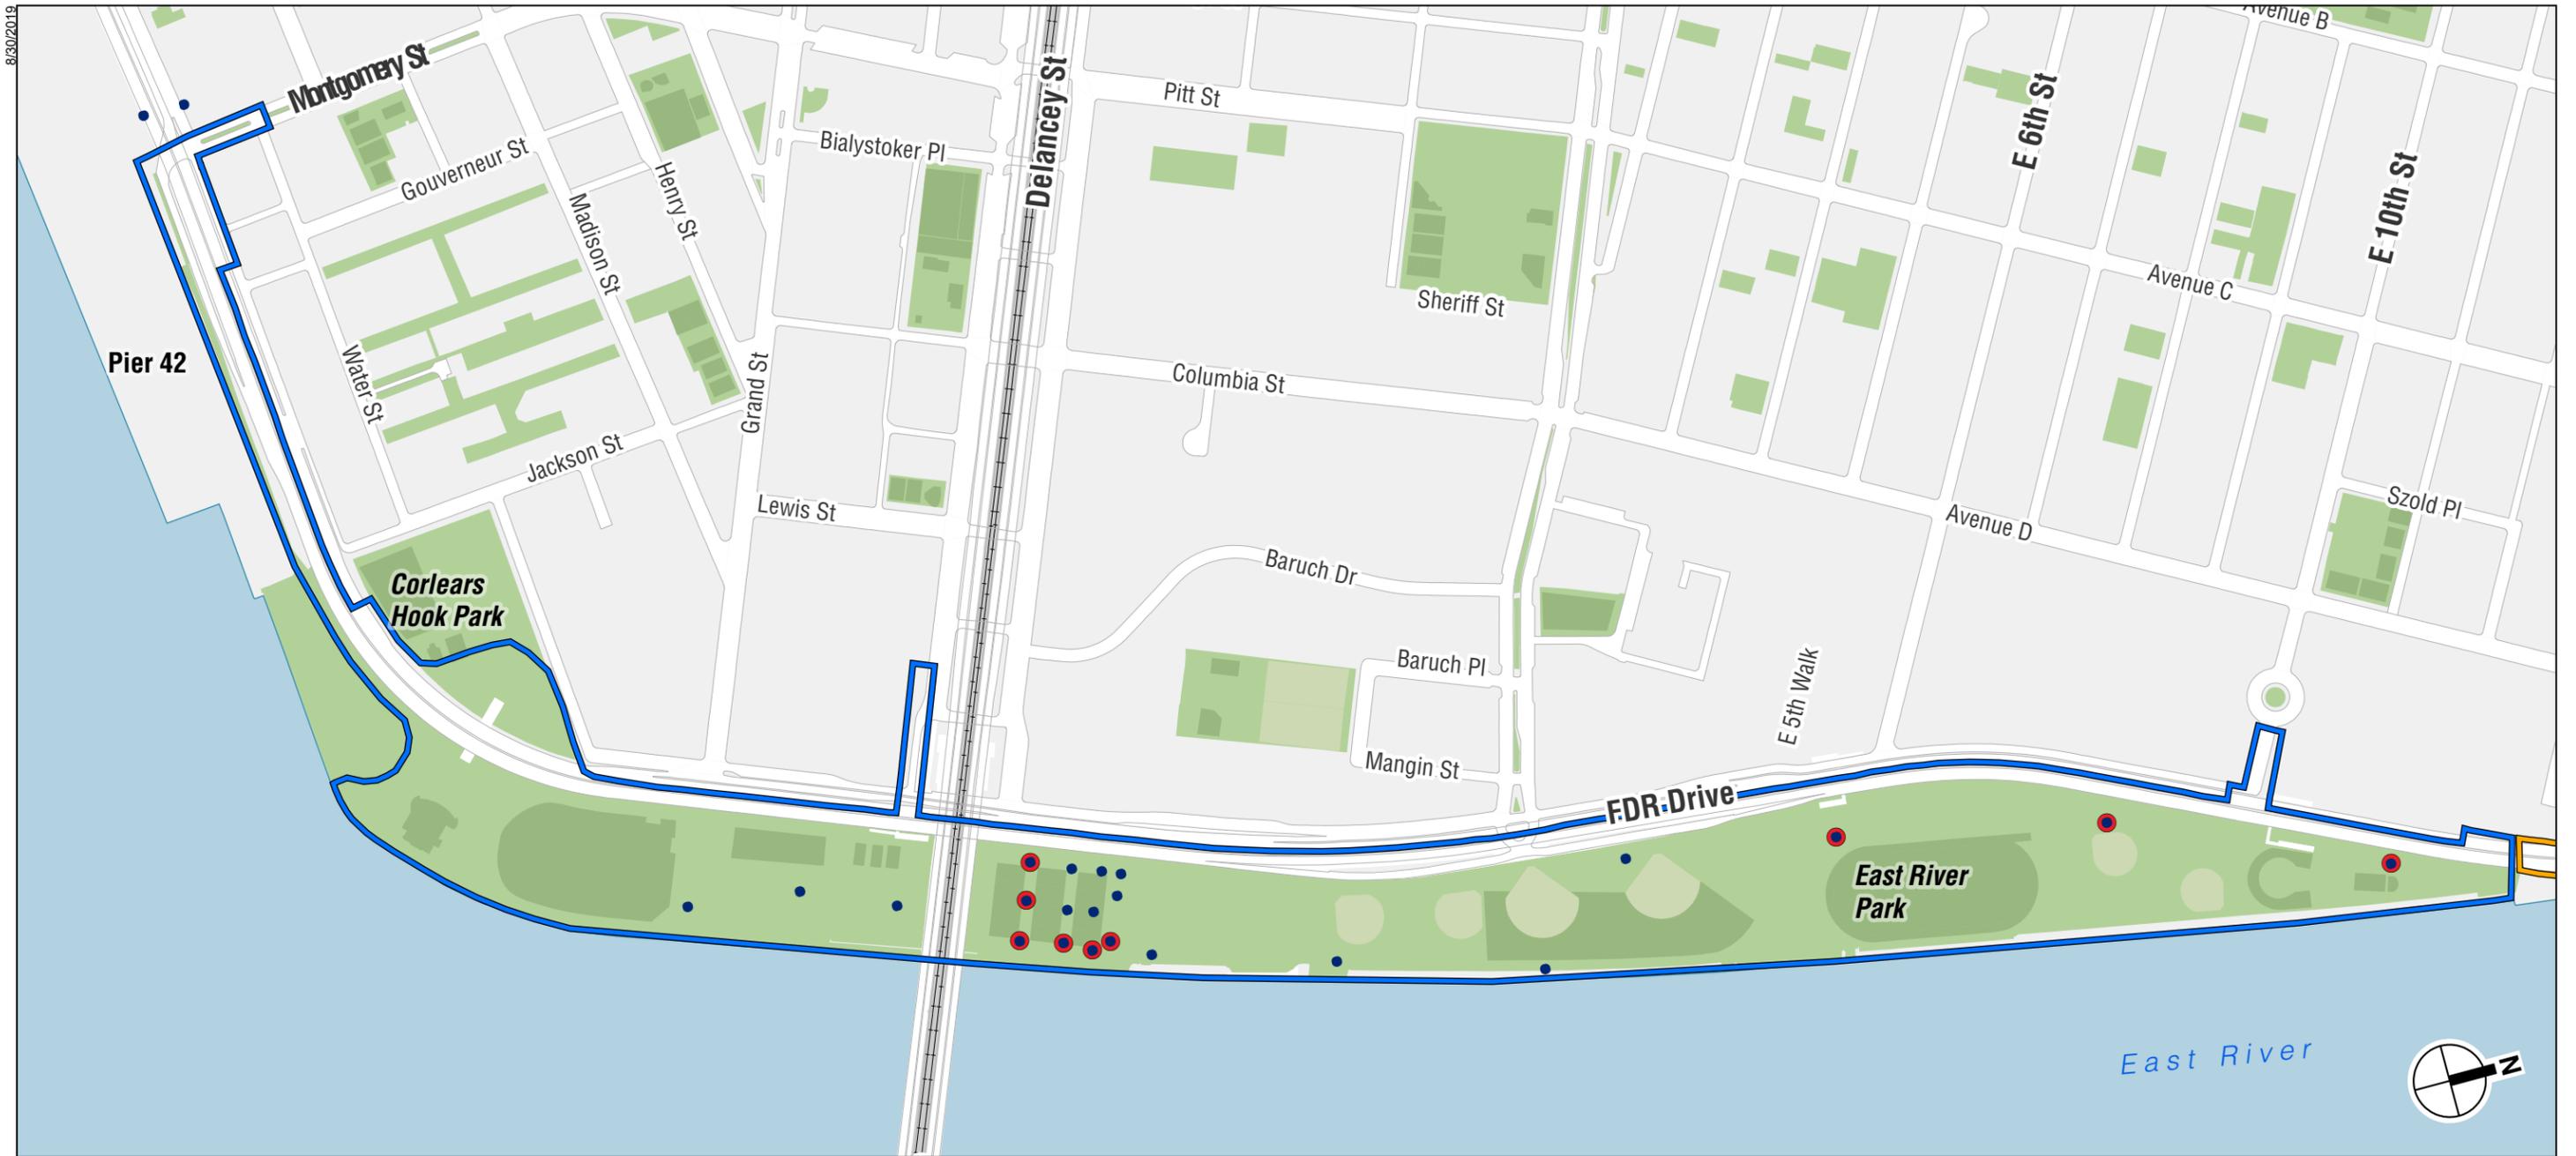
- Project Area One
- Project Area Two
- Soil Boring Location & Designation
- Soil Borings with Coal Tar-Like Contamination Encountered at Depths

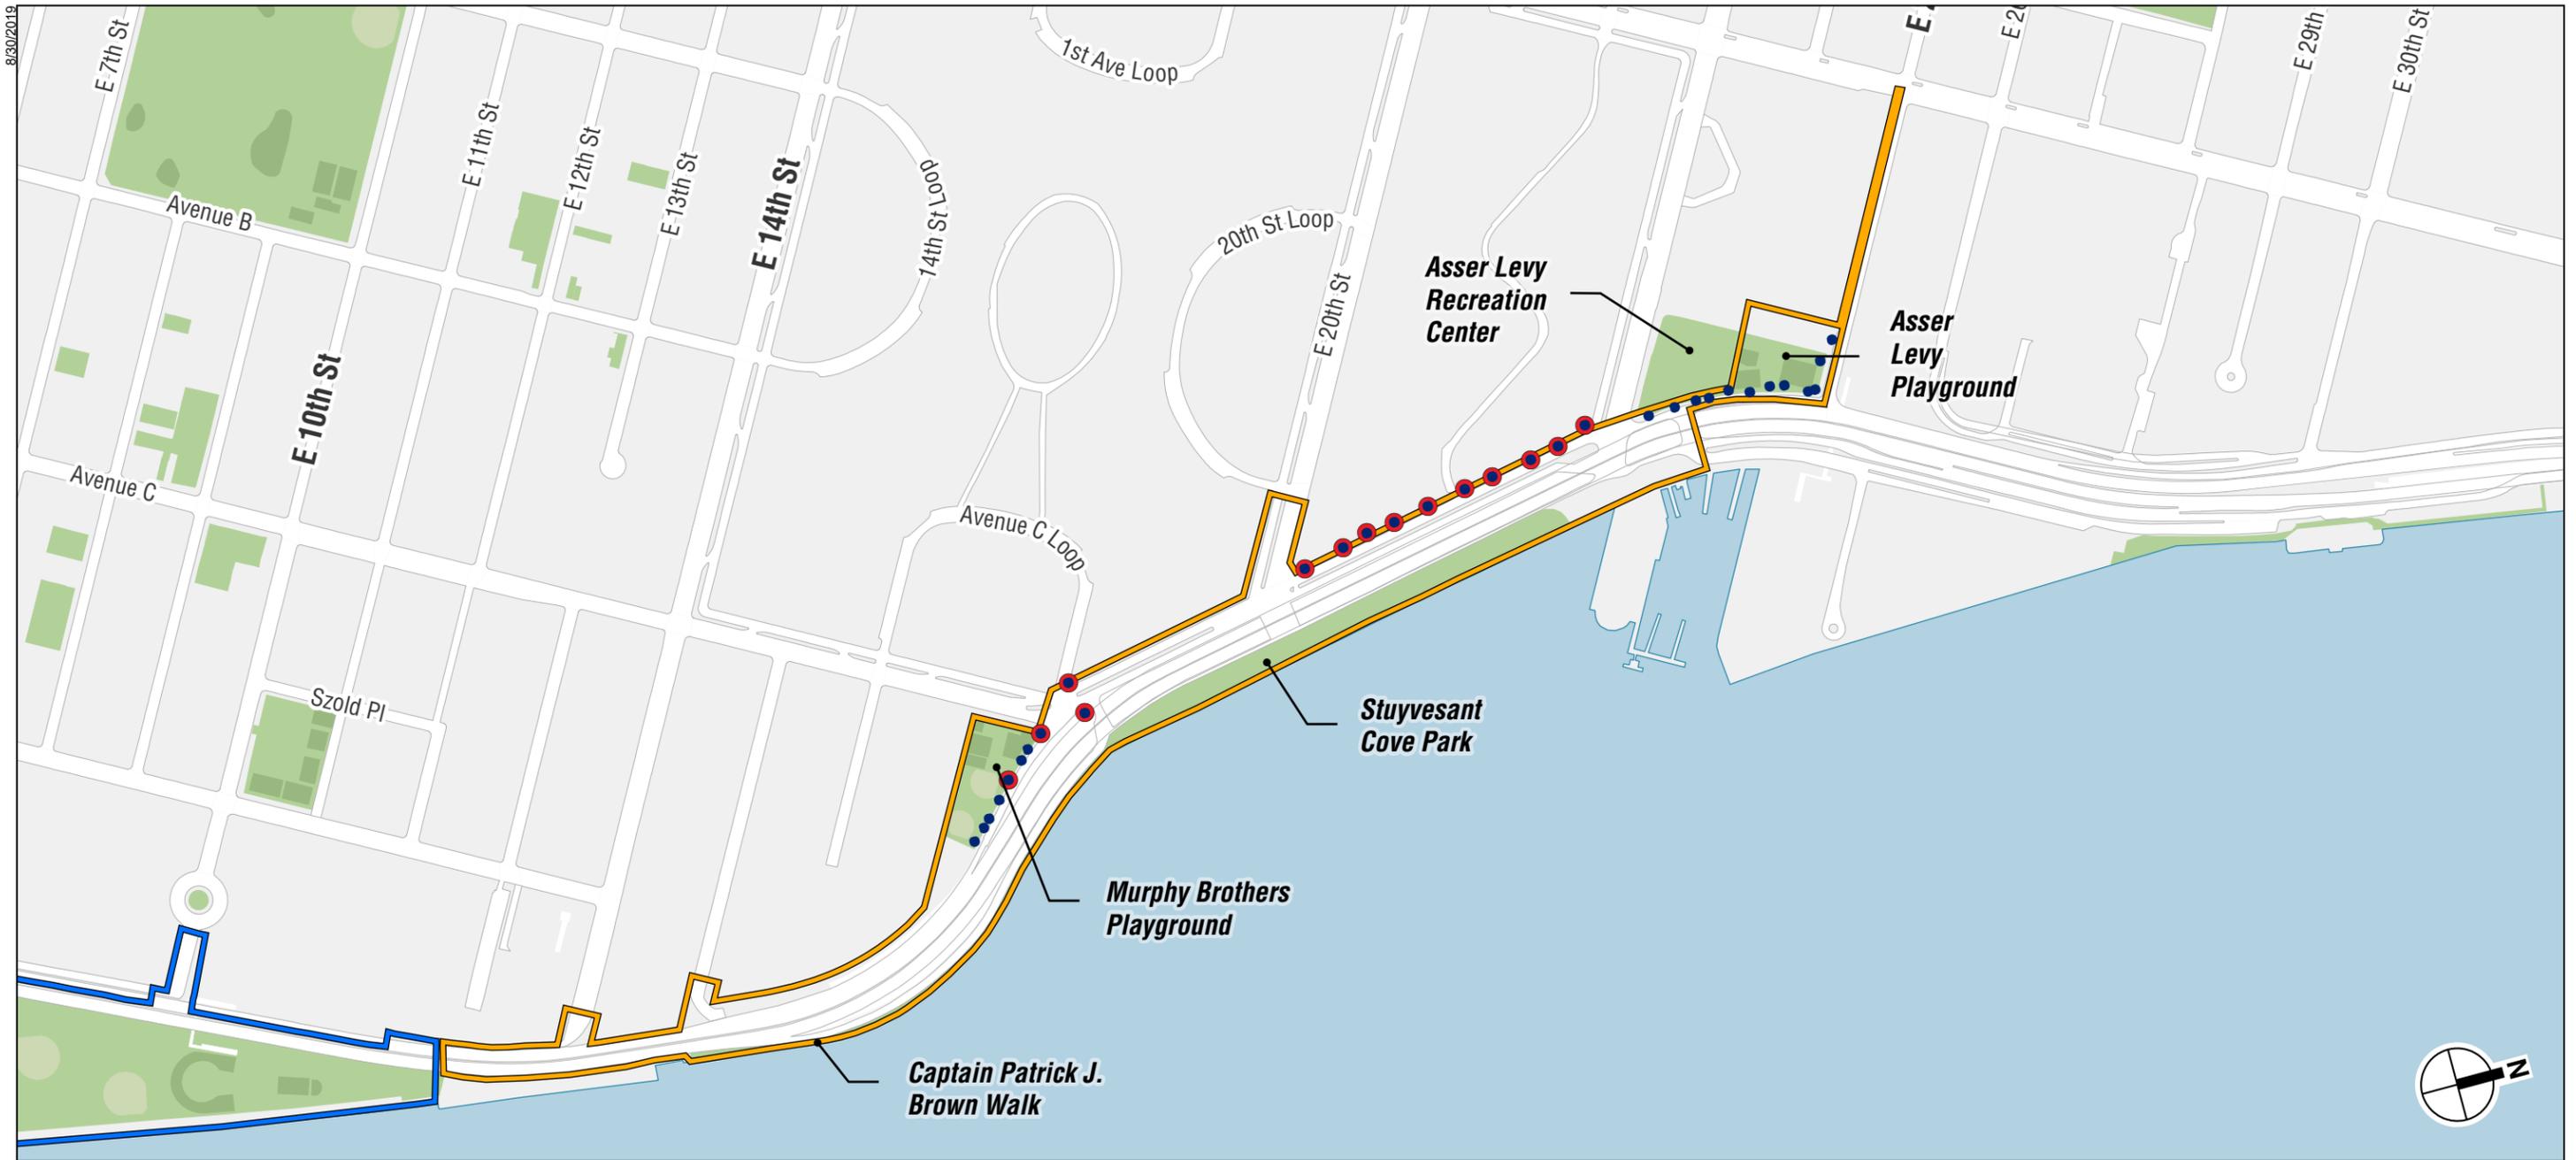
- Project Area One
- Project Area Two
- Soil Boring Location & Designation
- Soil Borings with Coal Tar-Like Contamination Encountered at Depths

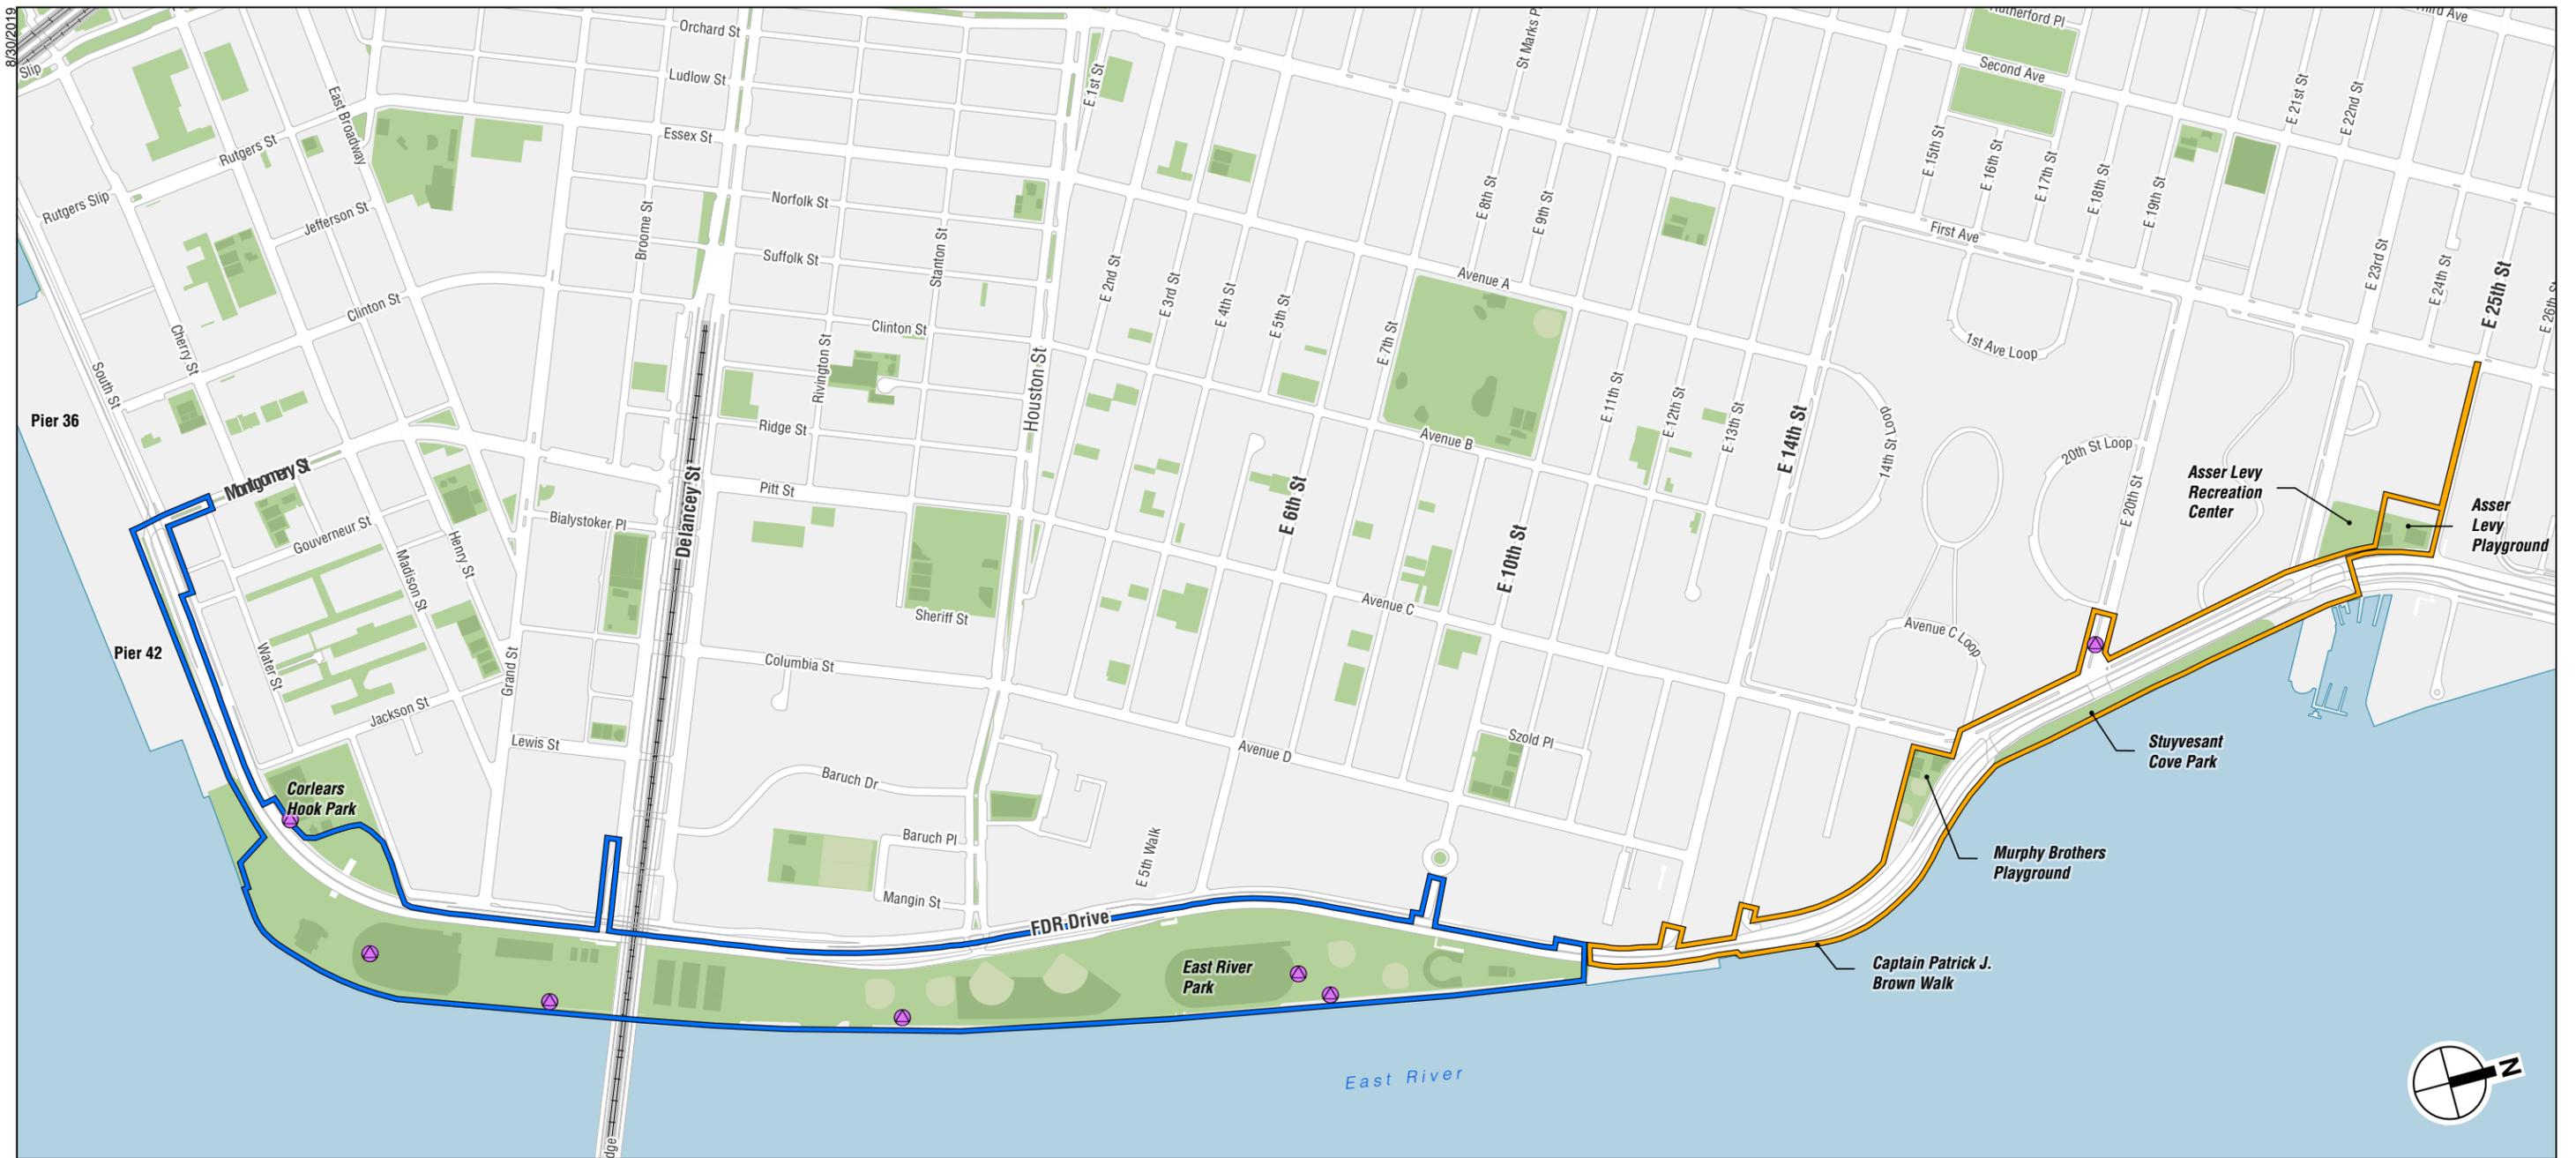
- Project Area One
- Project Area Two
- Groundwater Sample Locations

A supplemental soil and groundwater investigation was conducted in June and July 2019 to evaluate subsurface conditions in previously untested areas (see **Figures 5.7-7 through 5.7-9**), where subsurface disturbance would occur based upon the changes in the alignment of the flood protection system in Project Area One, and upon the modified proposed locations of two interceptor gates at the northern and southern portions of the project area.

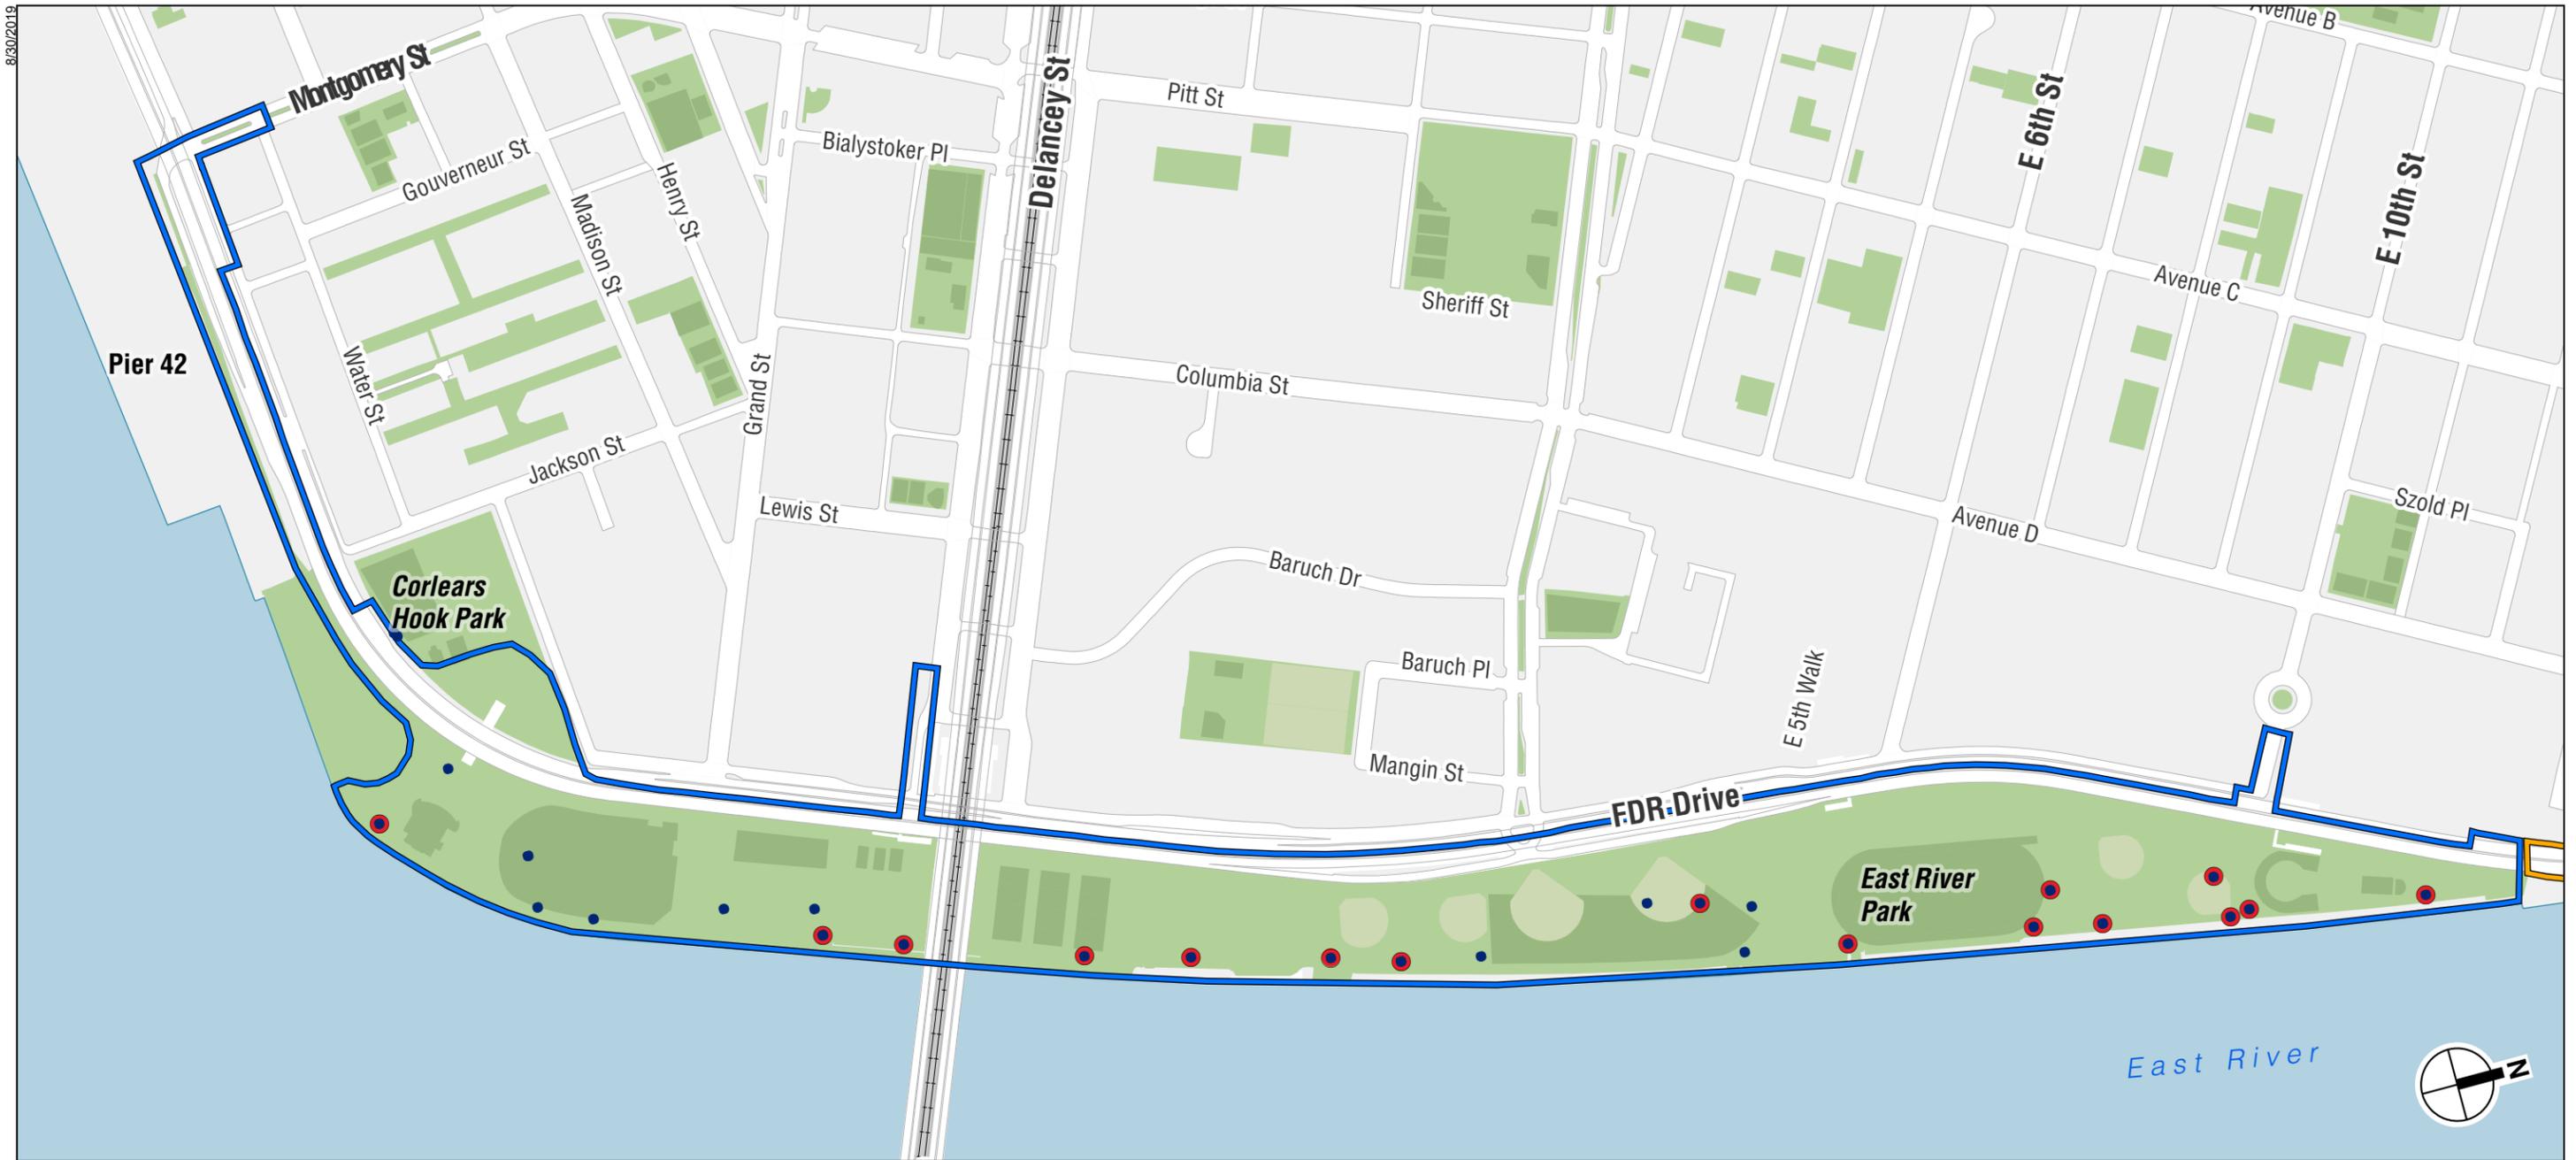
- Project Area One
- Project Area Two
- Soil Boring Location & Designation
- Soil Borings with Coal Tar-Like Contamination Encountered at Depths
