A. INTRODUCTION

The proposed project would involve the installation of a flood protection system generally located within City parkland and streets between Montgomery Street to the south and East 25th Street to the north. The proposed flood protection system would consist of a combination of floodwalls, levees, and/or closure structures that, together with other infrastructure improvements, would improve the resiliency of this area to coastal flooding while simultaneously improving access and community connectivity to the waterfront. The proposed project would require the demolition or disturbance of existing structures, excavation,² and disturbance and removal of some of the existing fill and soil, with the importation of fill material to raise the ground level throughout East River Park. Dewatering of groundwater would also be required. A detailed description of the alternatives analyzed in this chapter is provided in Chapter 2.0, “Project Alternatives.”

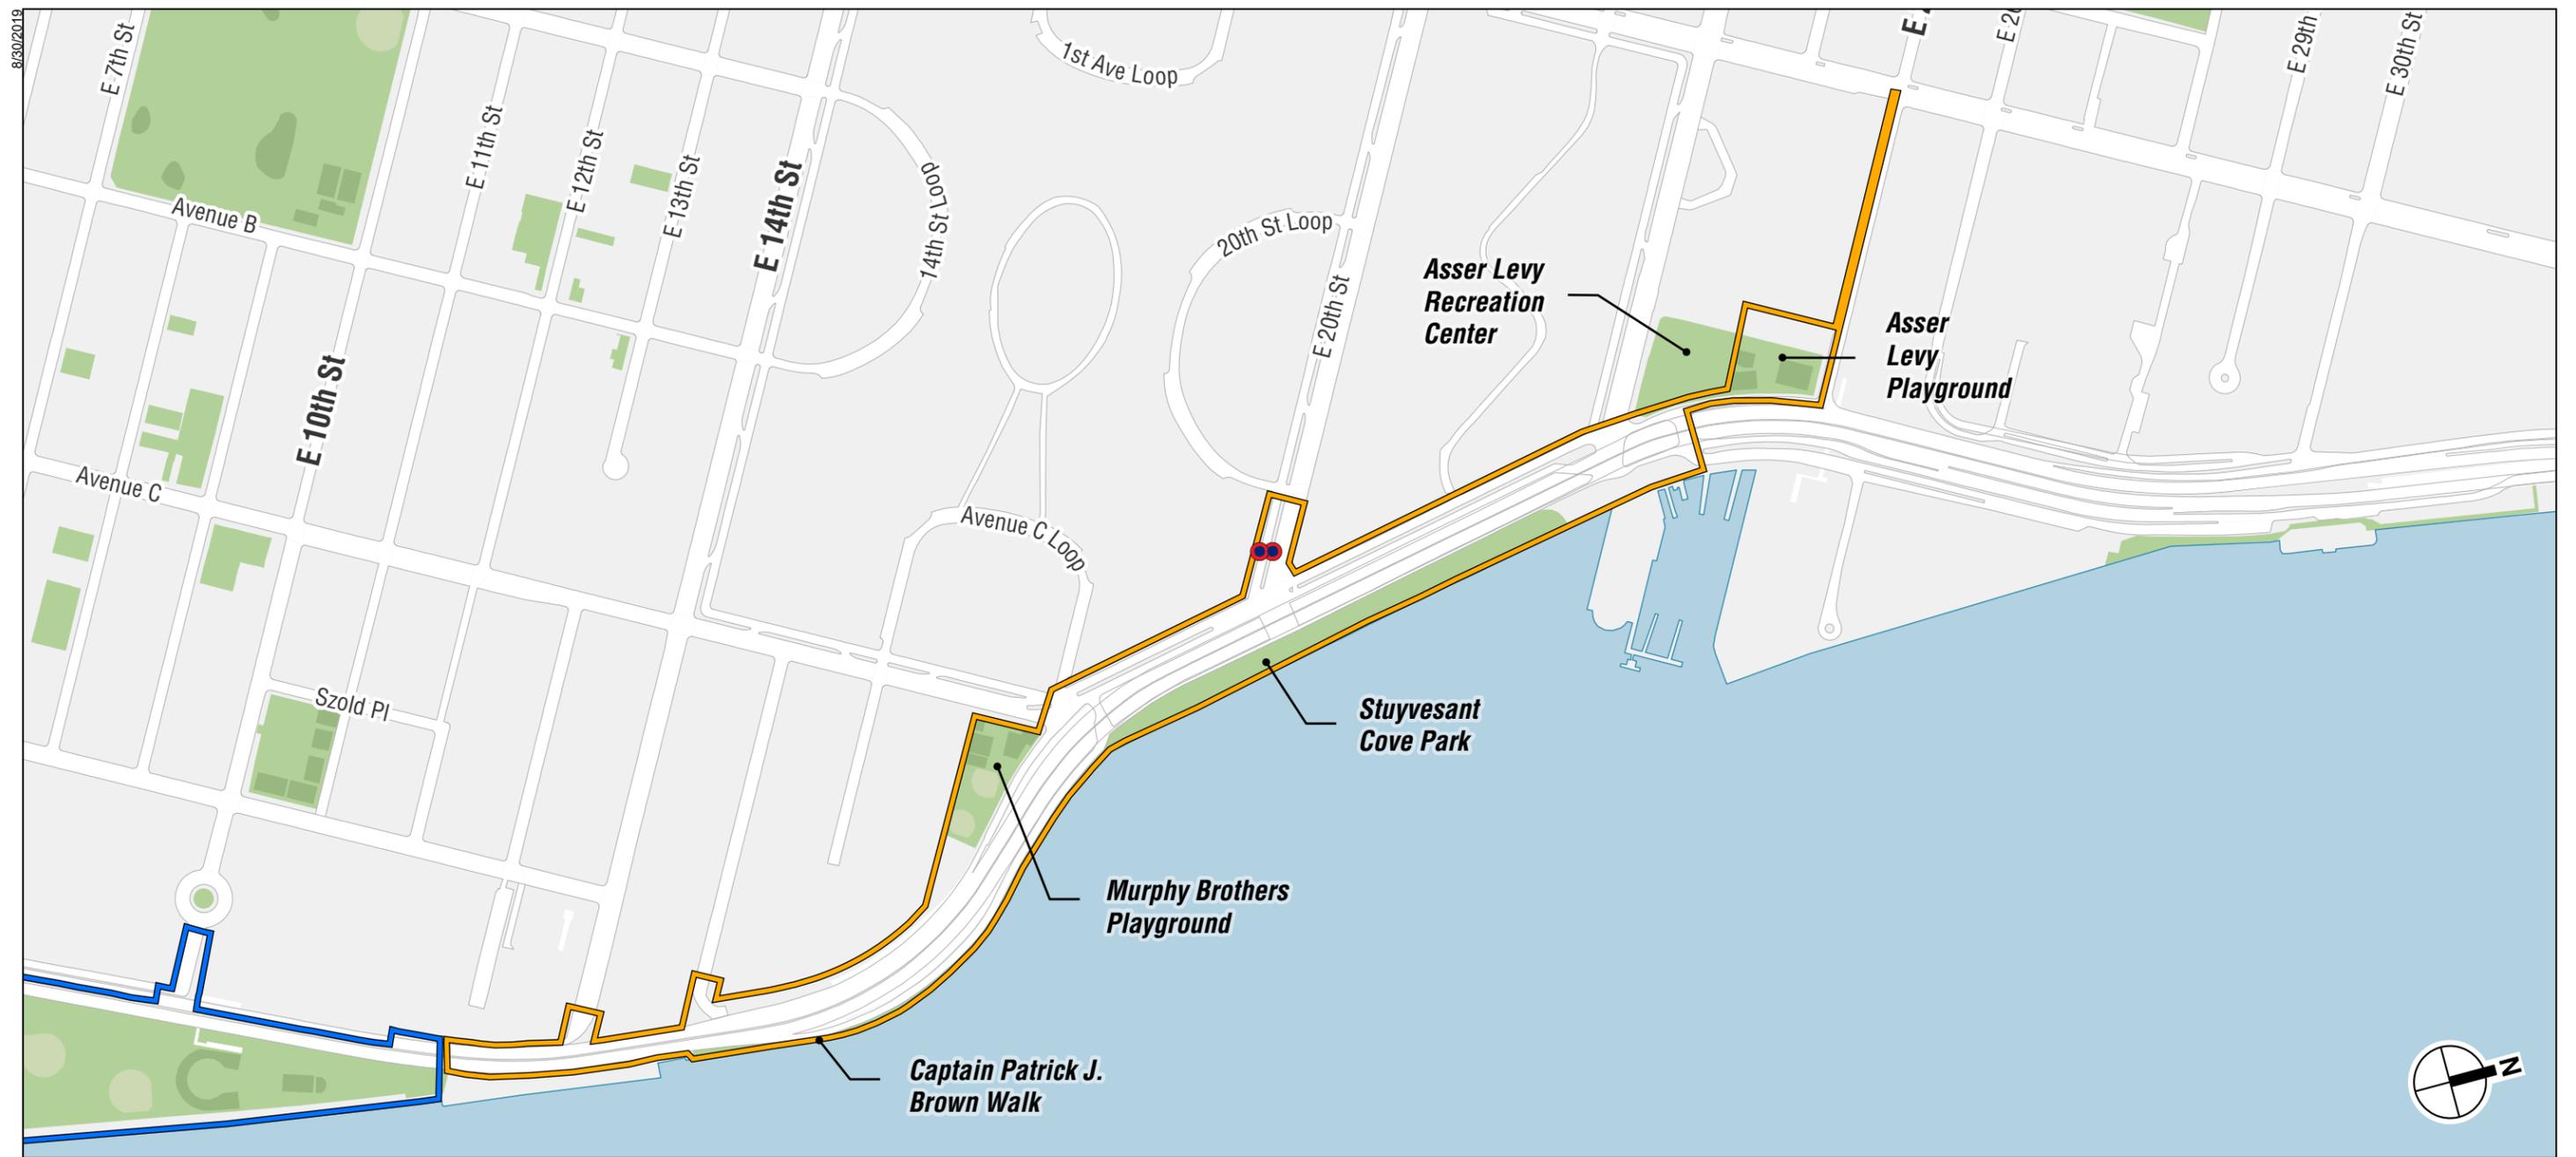
- Project Area One
- Soil Boring Location & Designation
- Project Area Two
- Soil Borings with Coal Tar-Like Contamination Encountered at Depths

A supplemental soil and groundwater investigation was conducted in June and July 2019 to evaluate subsurface conditions in previously untested areas (see **Figures 5.7-7 through 5.7-9**), where subsurface disturbance would occur based upon the changes in the alignment of the flood protection system in Project Area One, and upon the modified proposed locations of two interceptor gates at the northern and southern portions of the project area.

Petroleum-like odors and or low-level photoionization detector (PID) readings, indicating the presence of VOCs, were noted during the field screening of soil from 12 borings as shown on **Figures 5.7-2, 5.7-3, 5.7.5, 5.7.6, 5.7.8, and 5.7.9**. However, laboratory data indicated potential petroleum contamination in only three of these borings—one located slightly south of East Houston Street, one just north of the Williamsburg Bridge, and another near the Solar One site.
